EVALUATION OF CHEMICAL EROSION CONTROL AGENTS

R. L. MEARNS

642126
April 1973

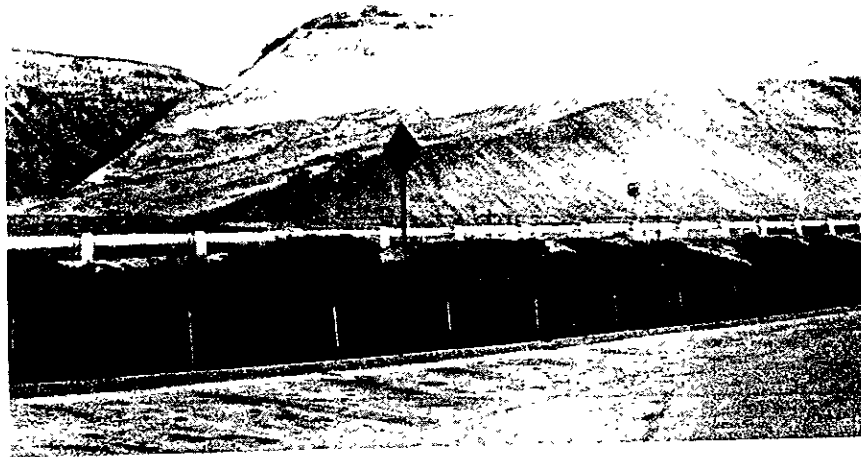
Plate 2 - Appearance of the Slope at the Time of Treatment

The southwest orientation of the slope face exposed these chemicals to direct attack by the sun's rays and the winds and rains associated with storms in that area. "Soil-Lok" was the most durable material known at the time of treatment. It was therefore anticipated that a limit to the effective life of spray-on treatments could be determined by this experiment. It was also reasoned that the presence of the highly erodible sand layer would permit visual evaluation of the effectiveness of Soil Seal and Soil-Lok when compared to the untreated area. The chemical treatments were made in September 1971 and inspected in January and November 1972 and April 1973. No quantitative evaluation was deemed necessary as the readily discernible conditions of the slope offered face validity. Plates 2 and 3 show the slope and bench at time of treatment.

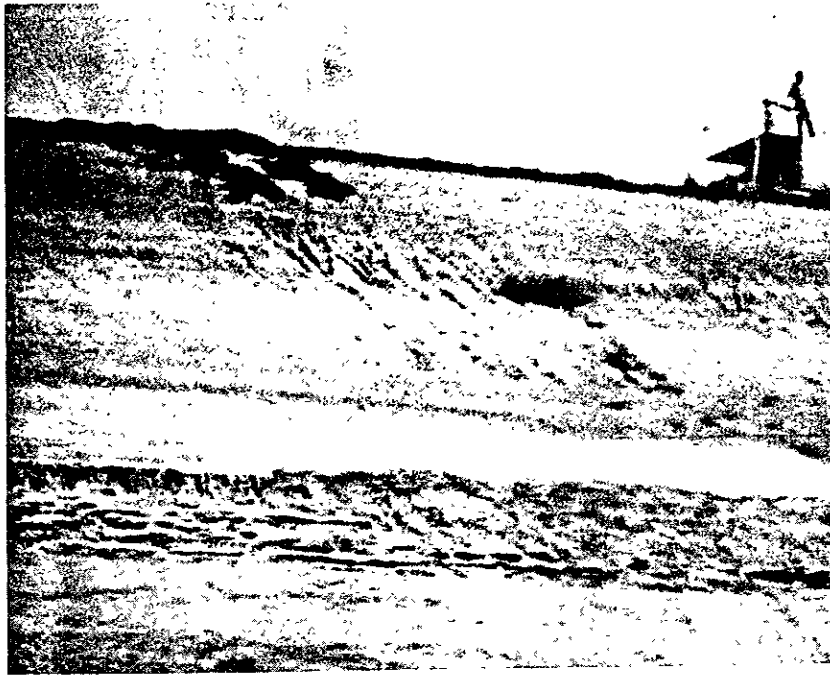
An inspection of the test area conducted in January 1972 showed that the untreated area had developed small-scale gullies and had collected large quantities of debris on the benches (see Plates 4 and 5).

Plate 4 - Gullies in Untreated Area (Right) with
Uneroded Soil-Lok Area (left)

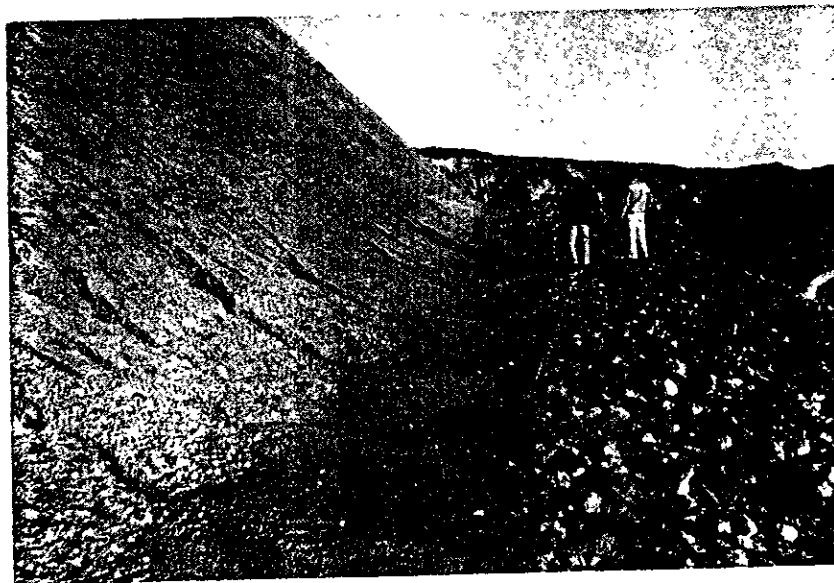
Plate 5 - Debris on Bench. Untreated Area in Fore-
ground, Soil Seal Treated Area in Background

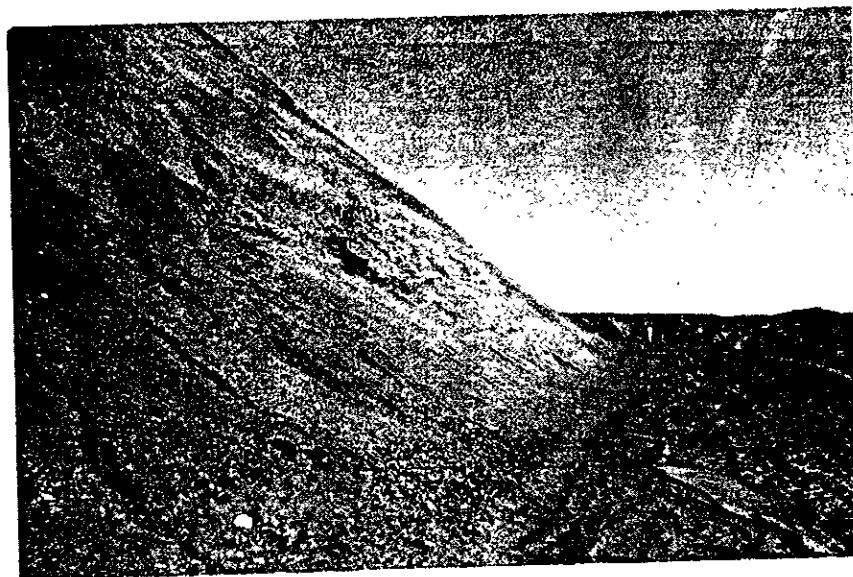
At the time of this inspection no trace of a surface crust of Soil Seal could be found anywhere. The rye seed that had been applied with the Soil Seal had either washed into pockets on the slope or onto the bench. The Soil Seal as used on this project was concluded to be totally ineffective. The Soil-Lok, however, had formed a hard and nearly continuous crust which resisted erosion up to that time (see Plate 6).

Plate 6 - Lack of Debris on Bench Below Soil-Lok Treatment.

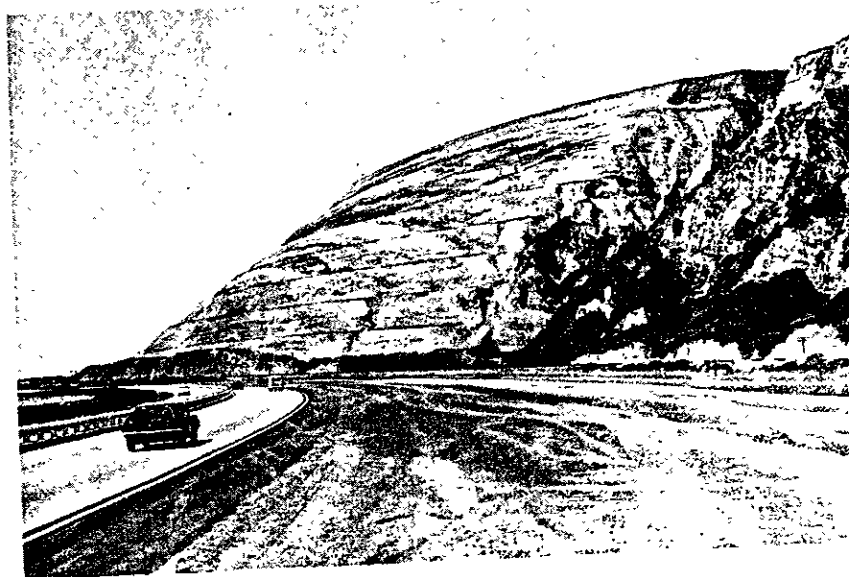
Plate 7 - Appearance of Cut Slope, 4-5-73

A final inspection of the site was made April 5, 1973. The overall appearance of the slope at that time is shown in Plate 7. The scattered grass on the slope is nearly all barley. The seed for this vegetation apparently came from the field at the top of the cut which is planted in barley this year.

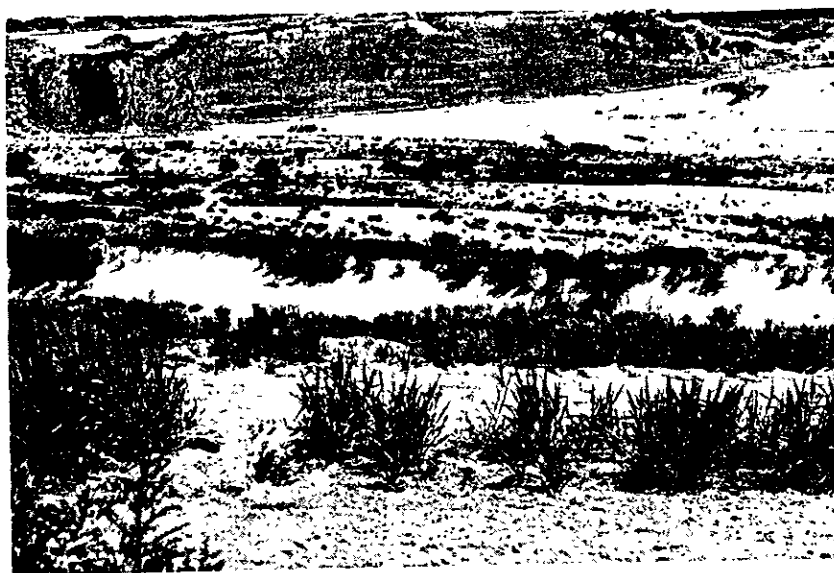
Plate 10 - Bench Below Soil Seal Test Plot

Plates 10 and 11 are taken looking down the test slopes from the top of the cut. Plate 10 shows the bench below the Soil Seal treated slope. A layer of fine sand deposited from this year's storms can be seen to cover the surface. The bench shown in this picture is identical in appearance to the bench below the untreated slope. The thickness of the sand has resulted in development of a rather sparse vegetative cover. In contrast to this, the bench below the Soil-Lok (Plate 11) shows no sand buildup and is nearly completely grass covered.
